Fuel Induced Pitting Corrosion on Boiler Bottom Wall Tube of Steam Power Plant

Helena Carolina Kis Agustin and Ika Dewi Wijayanti*

Laboratorium of Metallurgy, Department of Mechanical Engineering,
Faculty of Industrial Technology, Sepuluh Nopember Institute of Technology
Kampus ITS Sukolilo, Surabaya 60111, Indonesia

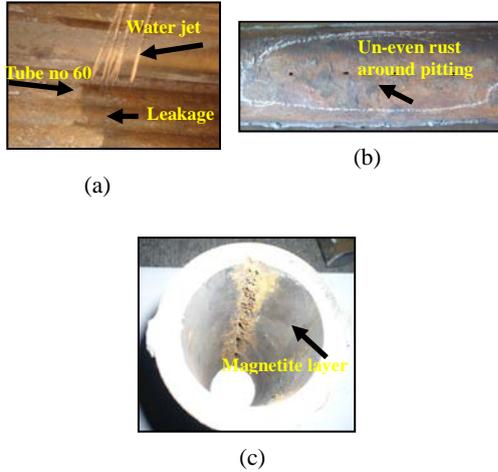
The leakage was found on the bottom wall tubes number 60 when hydrostatic test. Water jet passed through the pitting with leak as seen at Fig. 1(a). Damaged tube then was cut. The pitting with leaks were shown at Fig.

1(b). There was observed un-even rust around pitting with leaks in the outside tube. Groove were found exactly on the below the pitting with leak that cause the leakage as shown at Fig. 1(c).

Fig. 1. (a) The leakage was found when hydrotest tubes (b) Un-even rust around pitting with leak (c) Groove were found exactly on the below the pitting with leaks

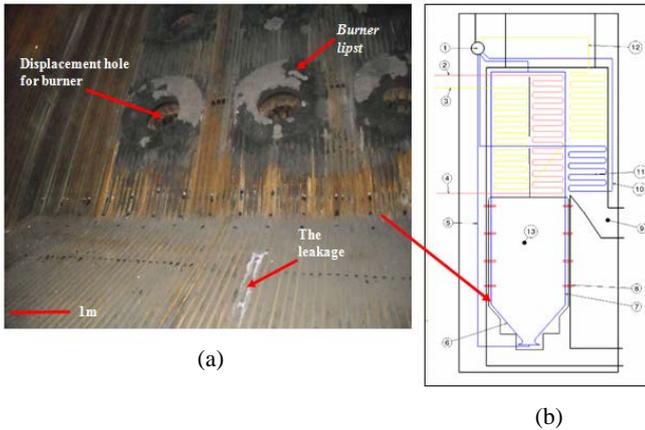
The leakage on the bottom wall tubes of boiler occurred at the exactly bottom of the displacement hole for burner as shown at Fig. 2(a) and side view at (b).

Fig. 2. (a) The leakage rear view truly (b) Side view

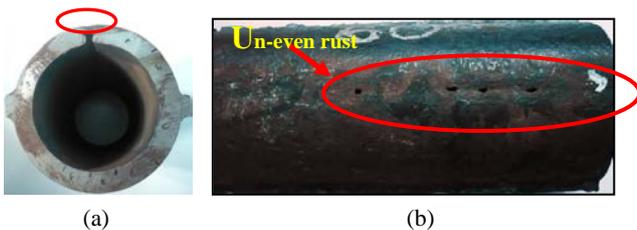
Fig. 3(a) shows the sectional deformation on the leakage tube. The pitting with leak formed the imperfect circle. Un-even rusts also were found around the leakage on the tube surfaces. There was found the change of diameter profile at the peak curve of tube as seen at Fig. 3(b).

Fig. 3. (a) The sectional deformation from side view (b) Top view

The protection layer was given on the outer surface tubes at the first operation. This may fail by time due to water jet cleaning process while the maintenance. When water jet cleaning was directed on to tube surfaces, the largest pressure will affect the peak curve of tube. This will cause the diameter deformation. Therefore the rust as the corrosion product was lost. Un-even pressure distribution may cause un-even rust on the tube surface. Continuously rust loss process occurred at the tube peak curve may cause the sectional deformation. The drops of electrolyte that contact on the naked tube surface were a local attack for the tube.

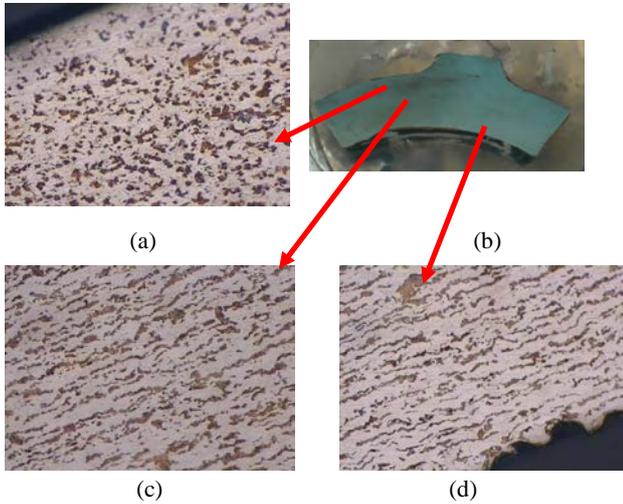
Fig. 5. (a) Top part microstructure view of normal tube (b) Normal tube sample (c) Middle part microstructure view of normal tube (d) Bottom part microstructure view of normal tube

Fig. 4 show the microstructure of normal tube which (a) top, (c) middle, and (d) bottom part view. These figures indicated that the grain unchanged because of plastic deformation or texture in spite of pressure and temperature. Microstructure texture shows flat grain shape due to forming process. Fig. 5(a) shows the beginning of failure magnetite layer which was marked by the surface roughness. The differences of grain shape between inside (Fig. 5(d)) and outside the tube (Fig. 5(a)) surface indicated that the force was received by inside tube has a tendency to be larger than outer surface tube.

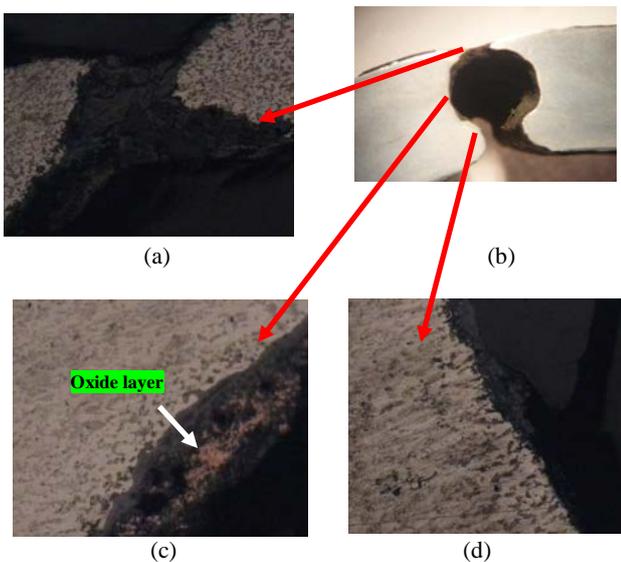
Fig. 6. (a) Top part microstructure view of pitting with leak tube (b) Pitting with leak tube sample (c) Middle part microstructure view of pitting with leak tube sample (d) Bottom part

microstructure view of pitting with leak tube sample

Fig. 6 show the microstructure of pitting with leak tube sample which (a) top, (c) middle, and (d) bottom part view. These figures indicated that pure corrosion occurred around the pitting and groove, considered the darker grains were compared with the grains that far away from the leakage. The corrosion propagated from one grains to other grains. The oxide layer was found on the unfail tube and it was lost on the fail tube which indicated local corrosion occurred. At the beginning, there was formed oxidation layer because of general corrosion. Due to the roughness of the surface tube that arise fluid flow turbulence, the oxide layer was eroded and followed by fluid flow (Fig. 6(a)).
