Fuel Induced Pitting Corrosion on Boiler Bottom Wall Tube of Steam Power Plant

Helena Carolina Kis Agustin and Ika Dewi Wijayanti*

Laboratorium of Metallurgy, Department of Mechanical Engineering,
Faculty of Industrial Technology, Sepuluh Nopember Institute of Technology
Kampus ITS Sukolilo, Surabaya 60111, Indonesia

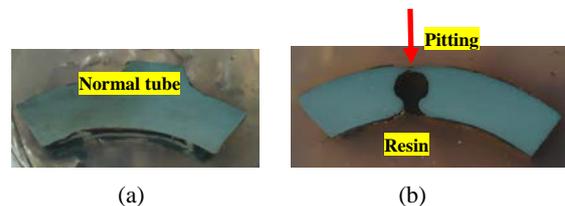
Fig. 4. (a) Normal tube sample for microstructure observing (b) Pitting with leak sample (c) Pitting without leak sample
